Patch holes in aluminum boats with G/flex[®] Epoxy

ALUMINUM BOAT REPAIR

By Randy Zajac and Rob Monroe

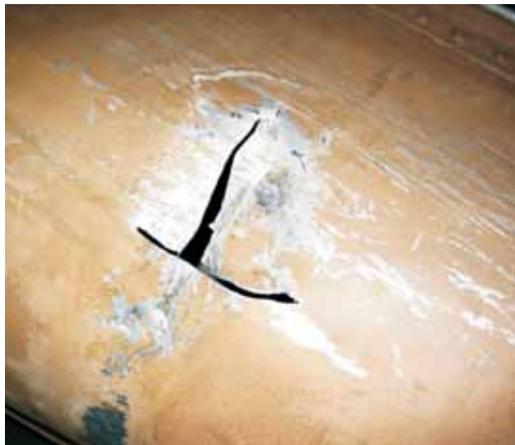
When we started testing G/flex Epoxy as a solution to leaky seams and rivets in aluminum boats, we put out a company-wide call for test boats. John Kennedy offered his old 15' Michi-Craft canoe, saying he would bring it down from his cabin at the end of hunting season. Not smiling, he asked a few weeks later "just how big a repair we could handle." It turned out John jack-knifed his utility trailer on an icy road, punching a fist-sized hole in the stern quarter of the canoe (*Photo 1*). Ouch.

Photo 1—The hole in John's canoe presented an opportunity to test the new G/flex and develop a repair technique to go with it.

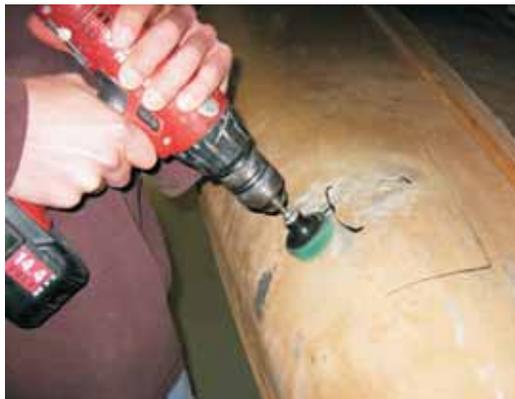
Photo 2—Left, a coarse 3M[®] Roloc[™] Bristle Disc did a good job of removing paint around the repair after it was hammered back into shape.

First, we hammered the torn aluminum out to near shape. The metal had yielded, so we cut away enough of the torn edges to allow the aluminum to lie fair. A hammer and an auto-body bucking dolly gave us reasonable control in getting the hull close to its original shape. We drilled stopper holes at the end of each tear to reduce the potential for crack propagation. Then we softened the edges of the aluminum with 120-grit sandpaper. We used a coarse 3M[®] Roloc[™] Bristle Disc to remove paint both inside and outside, giving ourselves plenty of bonding surface area around the hole (*Photos 2 & 3*). Finally, we used the two-part 860 Aluminum Etch Kit to prep the surfaces prior to bonding.

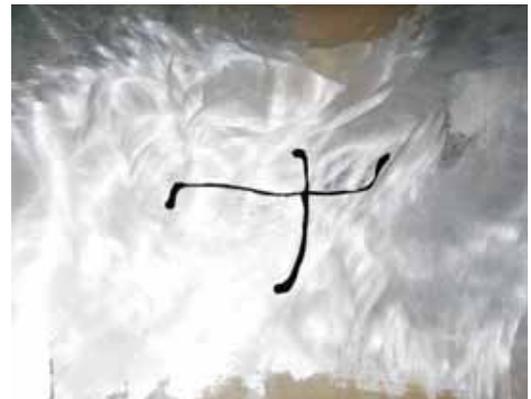
Photo 3—Right, the shaped and cleaned repair. Stopper holes were drilled at the end of each tear, and the surface was prepared with the 860 Aluminum Etch Kit.

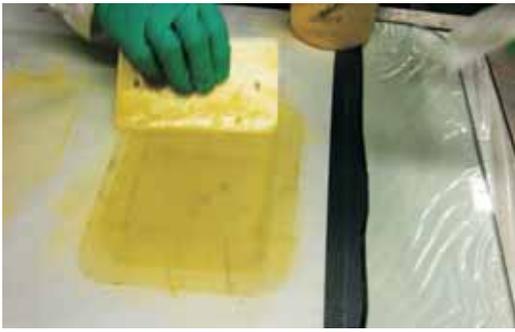
Photo 4—Left, 12 oz fiberglass patches for both the inside and outside were wet out with G/flex 650.

We laid out the patch pieces on plastic and wet them thoroughly with G/flex® 650 (Photo 4). We brushed both surfaces of the canoe with the G/flex, taking care to work the adhesive into the scratches and small dings. Finally, we mixed 406 Colloidal Silica with the residual adhesive in our cup to make a thickened mixture suitable for filling the holes and cutaways in the canoe (Photo 5).

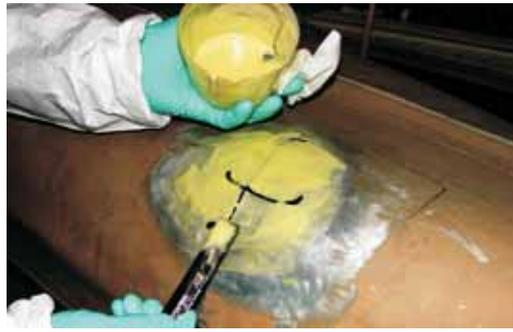
Photo 5—Right, Thickened G/flex 650 was applied to the repair area.

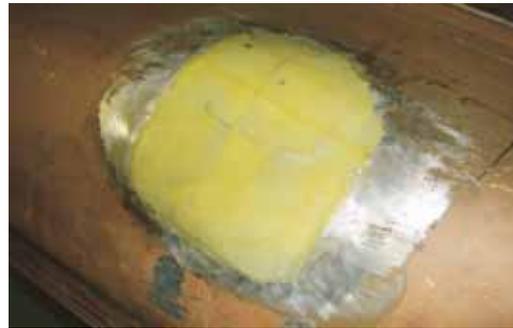
Photo 6—A single layer of glass was applied to the outside of the hull and smoothed into the thickened epoxy.

We started with the single layer outside patch, applying it to the hull centered over the hole and smoothing it into the thickened mixture (Photo 6). Working away from the canoe, we stacked up the three inner patches and squeegeed them to make sure there was no entrapped air. We then centered the stack of patches over the hole on the inside of the hull and carefully laid it into place (Photo 7). We squeegeed the patch very lightly to remove air. We then checked the outside of the hull to make sure that the pressure on the adhesive in the holes was not pushing the outer patch out of fair. When satisfied with the patch placement and fairness, inside and out, we let the patch cure overnight.

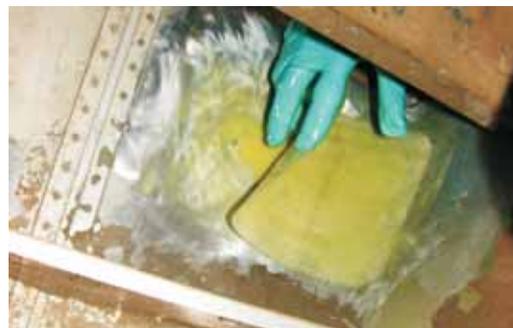
Photo 7—Three layers of glass were laid in position on the inside of the hull and lightly squeegeed to remove trapped air.

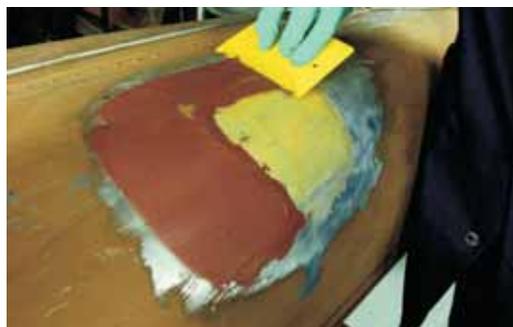
Photo 8—After edges of the patch were ground smooth, a mixture of 650 G/flex and 407 Low-Density Filler was applied to fair the patch inside and out.

The next day, we ground the edges of the patches to remove any roughness. We then applied a mixture of 650 G/flex and 407 Low-Density Filler to fair the patches (Photo 8). This “toughened” fairing compound smoothed the outside for better hydrodynamics and the inside for cleanliness and additional scuff resistance. We found that the fairing mixture sanded easily despite the flexibility of the G/flex Epoxy adhesive. It made a fine powder and didn’t seem to load up the abrasive media.

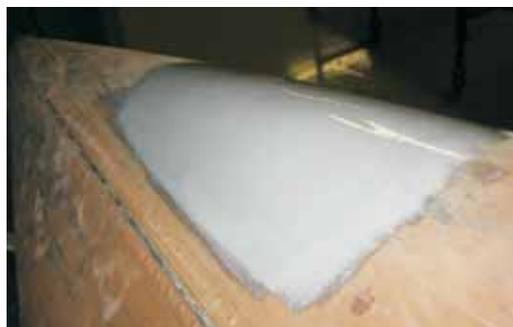
Photo 9—A mix of G/flex 650 and 503 Gray Pigment was applied as a sealer/undercoating and a bit of camouflage.

When the fairing mixture was cured, we applied a mix of G/flex and 503 Gray Pigment to supply a degree of camouflage for the fiberglass repair on an aluminum hull (Photo 9).
