# Repairing a Royalex™ Canoe with G/flex® Epoxy

By Bruce Newell and Stan Bradshaw

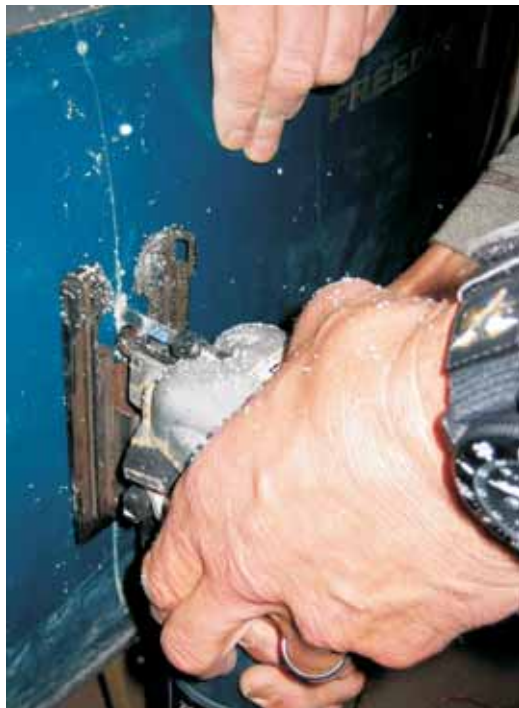
After drilling and countersinking the end of each crack, we used a saber saw to widen each crack prior to beveling rounding the edges.

We then used a saber saw to widen each crack. We followed this with either the corner of a 14" mill file or the corner of a chisel as a scraper to provide a widened beveled edge for each crack inside and out. (The file/chisel work was really fun, particularly when the corner of the tool would merrily skitter across the canoe, leaving decorative gouges, and we'd cheerfully cry out, "Don't tell Paul!") We cleaned up the resulting dumbbell-shaped groove with coarse sandpaper torn from an old belt and wiped everything down with denatured alcohol. The expanded crack made it easier to squeeze in a bead of G/flex 655 Adhesive and gave the glue a larger and keyed surface to which to adhere.

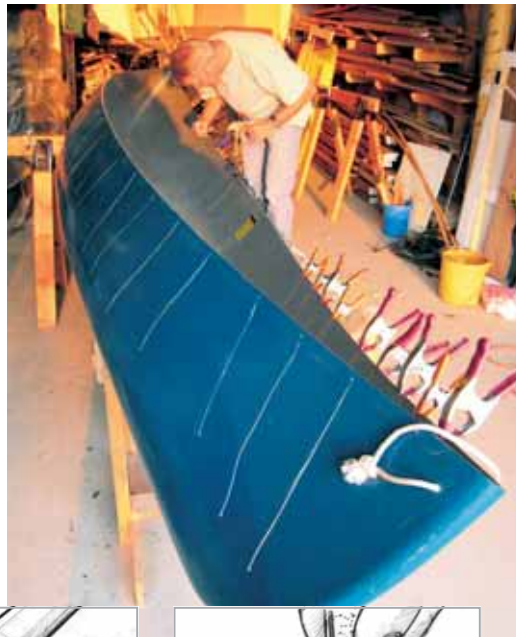
Stan Bradshaw taping cracks on the outside of the canoe with clear tape, readying cracks for G/flex injection.

To keep glue off the garage floor, we used cheap clear packaging tape as a backing on the outside of the canoe, and loaded our syringe with nearly bubble-free G/flex using WEST SYSTEM® 804 Mixing Sticks. Clamps along the sheer held the now very floppy hull in its original shape.

From the inside of the cradled canoe, we injected each crack with straight G/flex, taking special care to force the epoxy to the bottom and along the edges of each crack. We ran tape over the wet epoxy to control slumping, to try to create a smooth surface and to preserve a smooth garage floor. After a few trial cracks, it became clear that it was easier to get something close to a flush surface on the outside of the boat by pressing with a finger along the outside tape as the glue was applied to the inside.

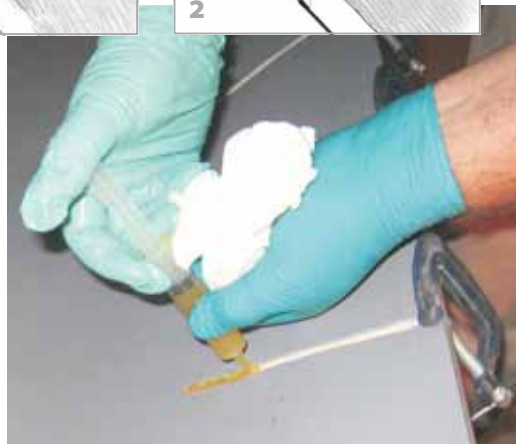
Injecting G/flex into a widened crack. Note paper towel in hand to clean up after rampant sloppiness.

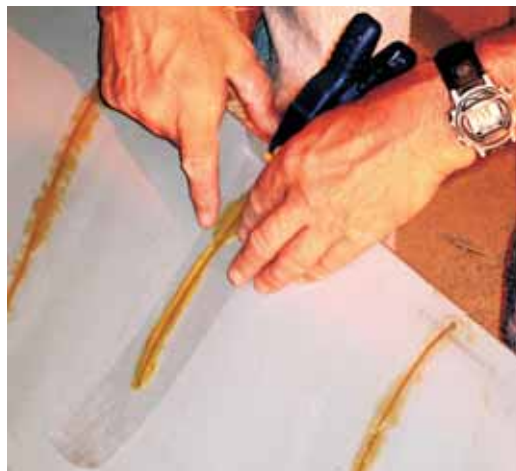
Stan running tape over freshly glued cracks to prevent the glue from running and keep it relatively smooth when cured. Note use of simple spring clamp to keep top edge of the Royalex aligned.

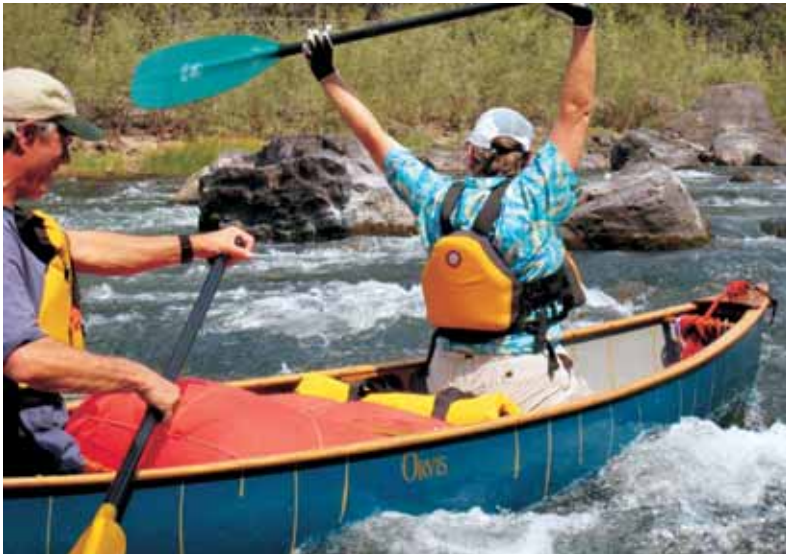
**Stan and Glenda Bradshaw in the freshly repaired Mad River, Freedom 16' Royalex canoe—repaired with G/flex Epoxy. I took the picture last August on the Blackfoot River, near Ovando, Montana, a couple miles downstream of Roundup Bar.**

After reattaching the breastplates, thwarts, seats, and gunwales, we thought it was time to test our repair. It was August, low-water time on Montana's Blackfoot River. Our favorite whitewater stretch was running clear, low, and very boney—there were rocks everywhere. Given the number of cracks repaired, Bruce thought we had at least a 50/50 chance of the boat actually floating, so he thoughtfully let Stan and his wife Glenda take first crack at padding the repaired boat. Like tipsy ranchers at a Grange dance, they slid over and bounced off more than a few rocks while dancing down a six-mile Class II+/III- stretch of enjoyable waves and eddies. To our amazement and considerable relief, the repair held. There wasn't even a hint of failure. We had a great day on the water, and G/flex proved to be a great way to cheat the dumpster and put a busted-up canoe back on the water. ■
